ROVER OWNERS' ASSOCIATION

Volume III, Number 6

December, 1974

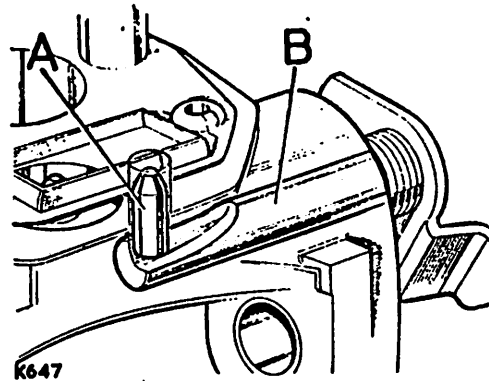
Our attention has been drawn to the increasing number of rear brake calipers returned to us under Warranty with inoperative hand brake mechanism.

Checks carried out on these units have shown that on the majority of calipers the ineffectiveness of the hand brake was due to the cam lever having been withdrawn during the removal of the caliper. This allows the tappet to drop out of its bore into the cavity, where it turns sideways and engages in the groove of the cam lever.

Fig. 1 Hand brake tappet correctly positioned in bore
A—Tappet correctly located B—Hand brake lever

If it has been necessary to withdraw the hand brake lever, ensure after refitting that there is a resistance when rotating the lever; this indicates that the hand brake tappet is correctly located.

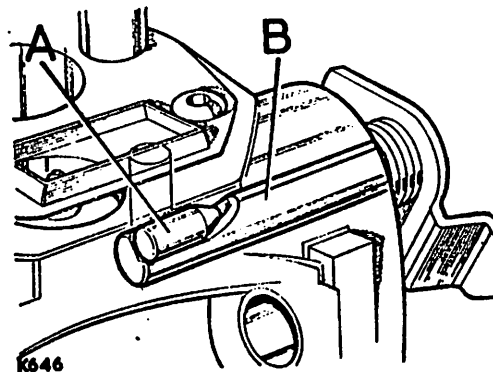
Fig. 2 Hand brake tappet incorrectly engaged on hand brake lever
A—Tappet incorrectly located B—Hand brake lever

It must be noted that as from the date of this News Letter Warranty claims will not be accepted for rear brake calipers, which are only suffering from a dislodged hand brake tappet.

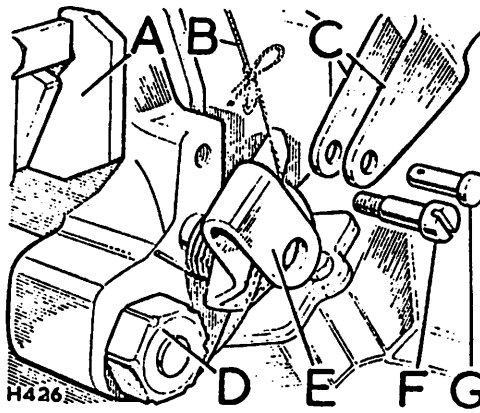
Fig. 3 Hand brake lever correctly secured, early models

On early models, when removing the stop pin for the hand brake lever, rotate the lever inwards as far as it will go and secure with a rubber band or string to prevent its withdrawal.

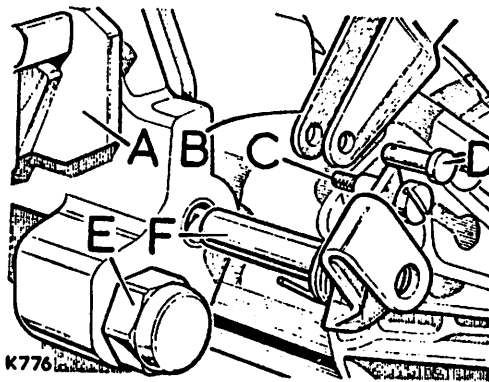
Fig. 4 Hand brake lever withdrawn, late models

On late models with the extended spring loaded plug it is necessary to withdraw the hand brake lever, to enable a spanner to be fitted on the hexagon of the plug.

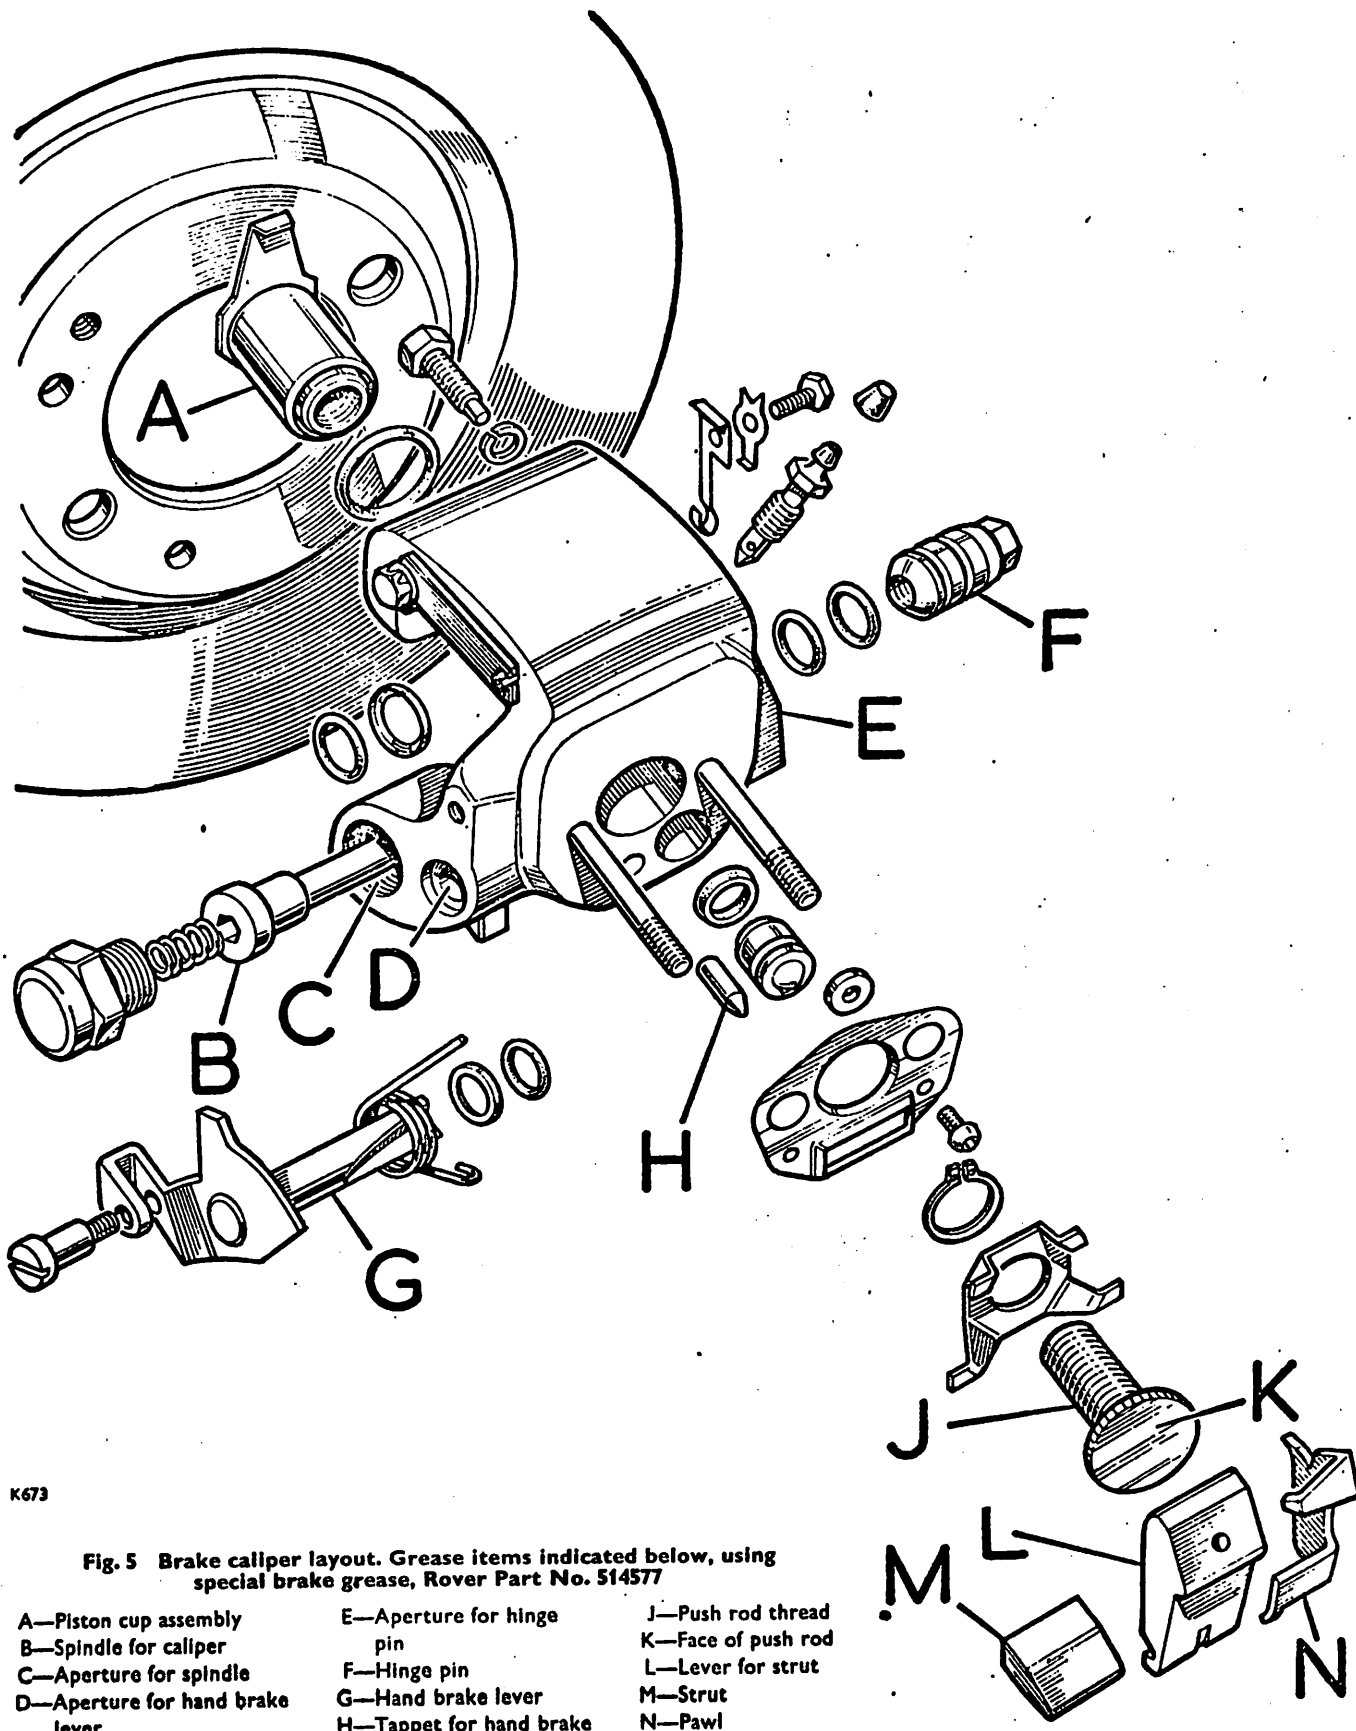
K673

Fig. 5 Brake calliper layout. Grease items indicated below, using special brake grease, Rover Part No. 514577

IMPORTANT. When reassembling a rear caliper after overhaul, etc. it is essential to grease the following items as shown. See Fig. 5. Use only special brake grease, Rover Part Number 514577. See also Rover Car News Letter, Vol. 2, No. 23, Item 259.

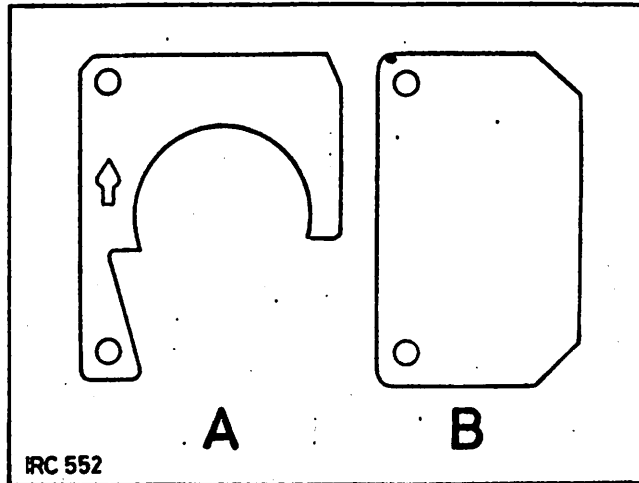
REMARKS: For a very limited period cars have left the factory with damping shims of an amended shape, although there was no change of part number.
Should a case of brake squeal be attributable to this, shims of the normal 'cut-away' type should be fitted and a Warranty claim submitted making clear reference to this News Letter.
For identification see Fig. 6.

Fig. 6. Brake pad damping shim identification
A—Correct shim B—Temporarily fitted shim

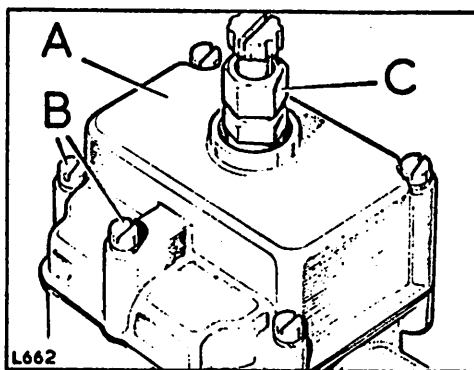
Our attention has been drawn to the fact that in many cases the jet assembly is being unscrewed for the removal of the float chamber, disturbing the jet setting in the process.

Fig. 2. Float chamber removal

A—Float chamber B—6 fixing screws
C—Jet assembly. Do not disturb when removing float chamber only

The float chamber can be lifted off after the six fixing screws have been removed. It should be noted that the rubber 'O' ring, which provides a seal between jet assembly and float chamber, can cause a certain amount of stiffness, when attempting to lift off the float chamber.

Should the jet assembly be inadvertently disturbed, the jet must be re-set and centralised as detailed in Part Two of the revised Land-Rover Workshop Manual, Part No. 606408.

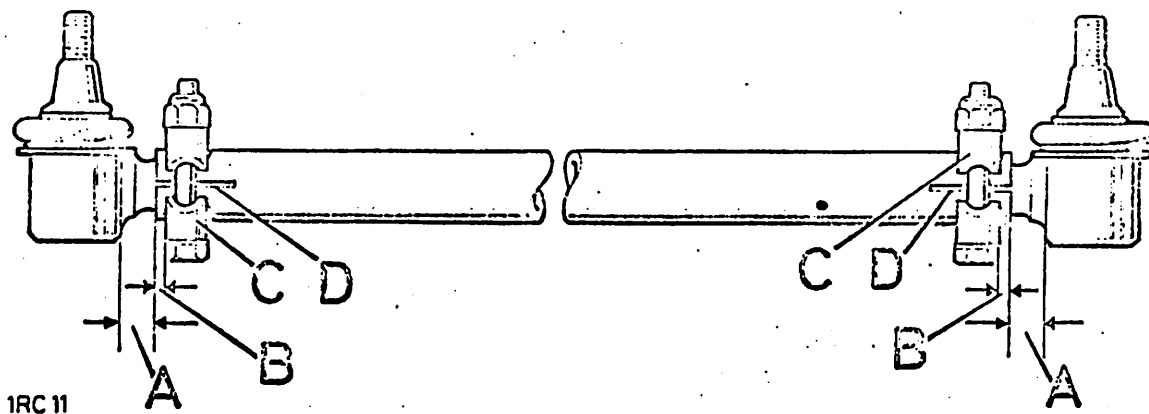
Fig. 1 Correct position of steering rod clips

- A—Must be equidistant between end of rod and ball joint
 - B—3 mm (0.125 in.)
 - C—Clip
 - D—Slot in steering rod
- } Slot must be positioned in the jaws of the clip as illustrated.

It should be noted that the highest clamping effect, in particular on linkages with one slot only, is achieved with the jaws of the clip situated over the slot, see Fig. 1.

Early type clips, Part No. 552038, which show evidence of distortion, should be replaced by the modified type, Part No. 577898.

The correct position of the clip is shown at Fig. 1.

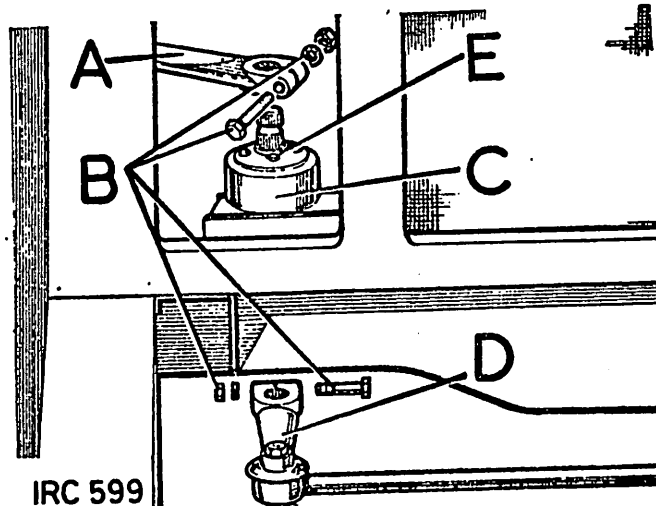
As a result of complaints of oil leakage from steering relay, Part No. 562874, investigations have been carried out which show that seals, Part No. 213340 have been damaged in a way which suggests the use of a lever or wedge to remove the relay levers.

Operation G1-9 in Land-Rover Workshop Manual, Part 2, Part No. 606408 instructs that the levers should be prised clear of the relay unit after the fixings have been removed, but the operation must be carried out carefully to avoid damage to the seals, Part No. 213340 and resultant leakage.

Fig. 4 Relay levers

A—Upper relay lever
B—Fixings for relay levers
C—Relay housing
D—Lower relay lever
E—Seal, Part No. 213340

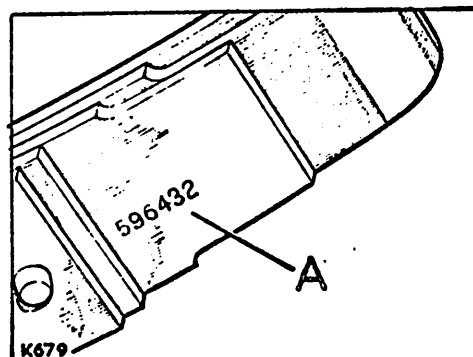
Fig. 1. Spring Identification

1. Check the part numbers to ensure that the correct springs are fitted. The Part No. is stencilled on the top face and stamped on the under face of one of the leaves. See Fig. 1 below.

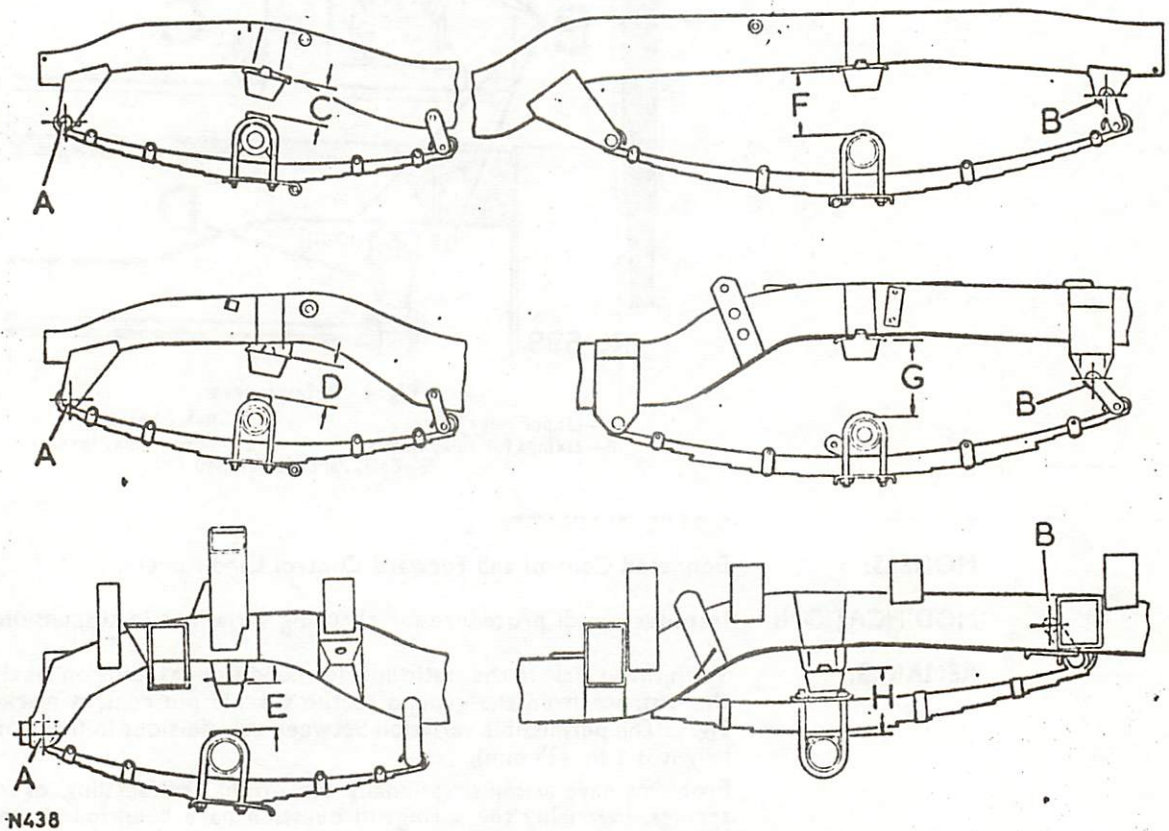
With the vehicle in the static unladen condition standing on level ground, measure the distance from the ground to the shackle pin centres marked 'A' and 'B' at Fig. 2. The permissible variation between vehicle sides in front or rear suspension height is 1 in. (25 mm).

Our investigations into this matter have established that the apparent settling is generally a result of 'wind up' in the shackle bushes.

Fig. 2. Presetting position of road springs to chassis frame

- A—Shackle pin centre, front spring
- B—Shackle pin centre, rear spring
- C—3.500 in. (89 mm) 88 Bonneted Control models
- D—3.750 in. (95 mm) 109 Bonneted Control models
- E—4.250 in. (108 mm) Forward Control models
- F—5.000 in. (127 mm) 88 Bonneted Control models
- G—6.000 in. (151 mm) 109 Bonneted Control models
- H—6.000 in. (151 mm) Forward Control models

2. With the vehicle weight taken off the road springs, remove the shackle pins. If they are not a free fit in their mating threads or in the rubber bush inner sleeves, this condition should be achieved by the use of emery cloth and oiling the threads, or if necessary, by reaming the holes through which the shackle pin passes.
3. All traces of Parkerising should be removed from the ends of the inner faces of the shackle side plates.
4. Replace the shackle pins, and on achieving the spring position detailed in Fig. 2, tighten first the shackle pin and then the lock nut to 70 lbs ft (9,6 mkg).
5. Allow the vehicle weight to be taken on the road springs.
