ROVER OWNERS' ASSOCIATION

Volume IV, Number 1

January, 1975

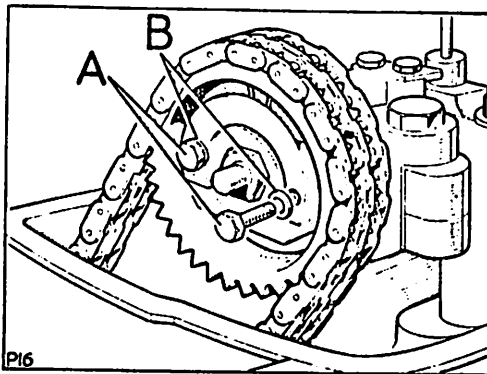
Fig. 1 Camshaft chainwheel

Investigations have revealed that a noise very similar to piston slap can be caused if the two camshaft bolts (fixing the camshaft wheel to the camshaft) foul the camshaft bearing block.

A—Bolts fixing camshaft wheel to camshaft B—Plain washer

When this noise occurs, a check on the camshaft bolt clearance should be made before carrying out extensive stripping of the engine. If a condition of camshaft bolt foul is encountered, it will be necessary to fit the above plain washers under the head of the bolts. See Fig. 1.

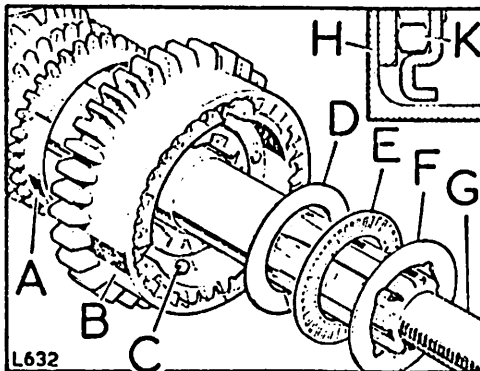
Fig. 2 Assembly of low gear synchronesh unit

A—Female cone for synchronesh unit	F—Scalloped thrust washer
B—Low gear synchronesh unit	G—Mainshaft
C—Dowels in synchronesh unit	H—Splined portion at centre of mainshaft
D—Plain thrust washer	J—Pressed cage of needle roller thrust bearing correctly fitted
E—Needle roller thrust bearing

When fitting the low gear synchronesh unit and thrust washers it is most important to fit the needle roller thrust bearing as shown at Fig. 2, that is with the radius of the thrust bearing cage towards the splined portion in the centre of the mainshaft.

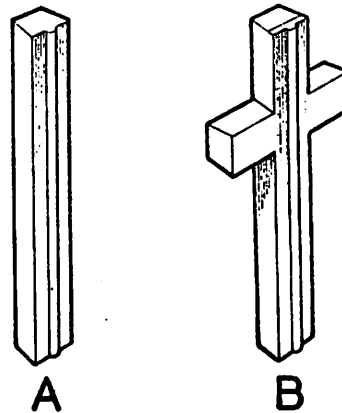
Fig. 2 Oil seal packing

The new oil seal packing, Part No. 611089 is 'Cruciform' in shape to overcome problems of it slipping out of position, see Fig. 2.

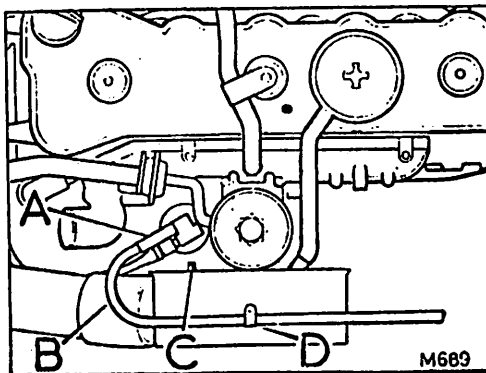
Fig. 1. Carburetter modification

A—Rubber tube (balance pipe) B—PVC piping, 15 in. (38 mm) long
D—'P' clip, drive screw and washer

When hot starting difficulties are experienced, the carburetter should be modified, as follows:

1. Remove the top of the float chamber and drill out the vent hole to $\frac{3}{8}$ in. (5 mm). Ensure the hole is clean, and replace the float chamber top.
2. Cut the rubber balance pipe in half. Discard one half and push the other half on to the PVC piping. Connect the piping to vent tube, and bend to pass over the air cleaner.
3. Drill a hole in the top of the air cleaner to take the drive screw (see Fig. 1).
4. Fit the 'P' clip over the pipe and secure to air cleaner with drive screw and washer.
5. Block up the hole in the air cleaner where the balance pipe was fitted, using the rubber plug.
6. Remove the carburetter needle and replace with the new 'KU' needle, checking that jet is correctly centralised.
7. Run engine until it has reached its operating temperature, and tune carburetter.

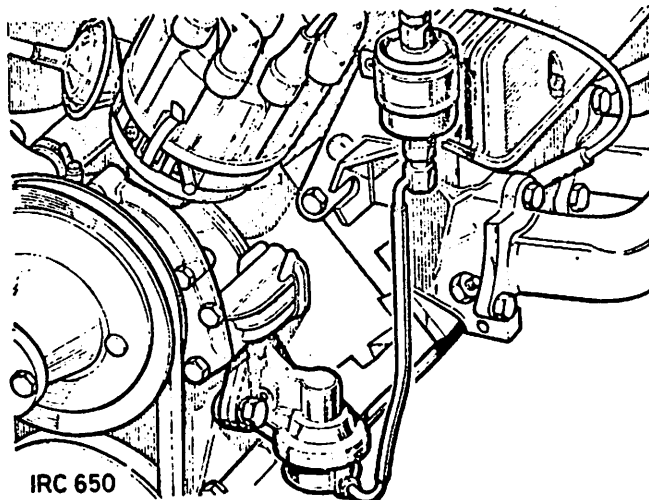
Fig. 2 Fuel pump location. 3500 model illustrated

If it becomes necessary to examine an engine for oil leaks the fuel pump mounting should not be overlooked.

Ensure that the fuel pump gasket is in sound condition and carefully examine the front cover mounting face for any signs of scoring or damage, which must be rectified. When refitting the pump the front cover mounting face and the pump flange should be treated with Hylomar SQ32 jointing compound.

The correct torque figure for the bolts fixing the fuel pump to the front cover is 2,8 to 3,5 mkg (20 to 25 lbs ft).

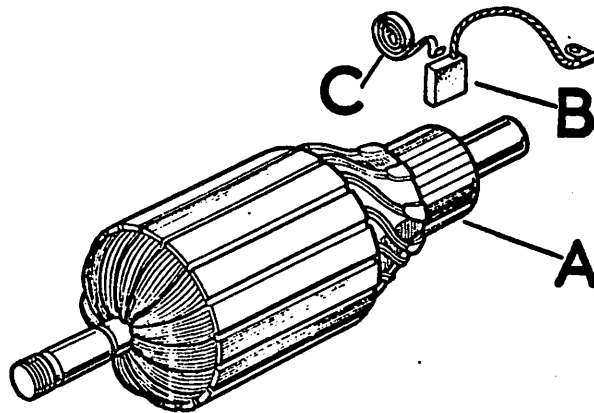
Fig. 3 Dynamo armature. 2½ litre petrol illustrated
A—Commutator B—Brush C—Brush spring

REMARKS: Complaints of dynamo noise have been investigated and in the majority of cases the noise has been found to emanate from the commutator.
It can be cured by the application of a small quantity (about the size of a match head) of M.S.4 silicone grease to the commutator.
This treatment does not affect the life or correct operation of the dynamo brushes.

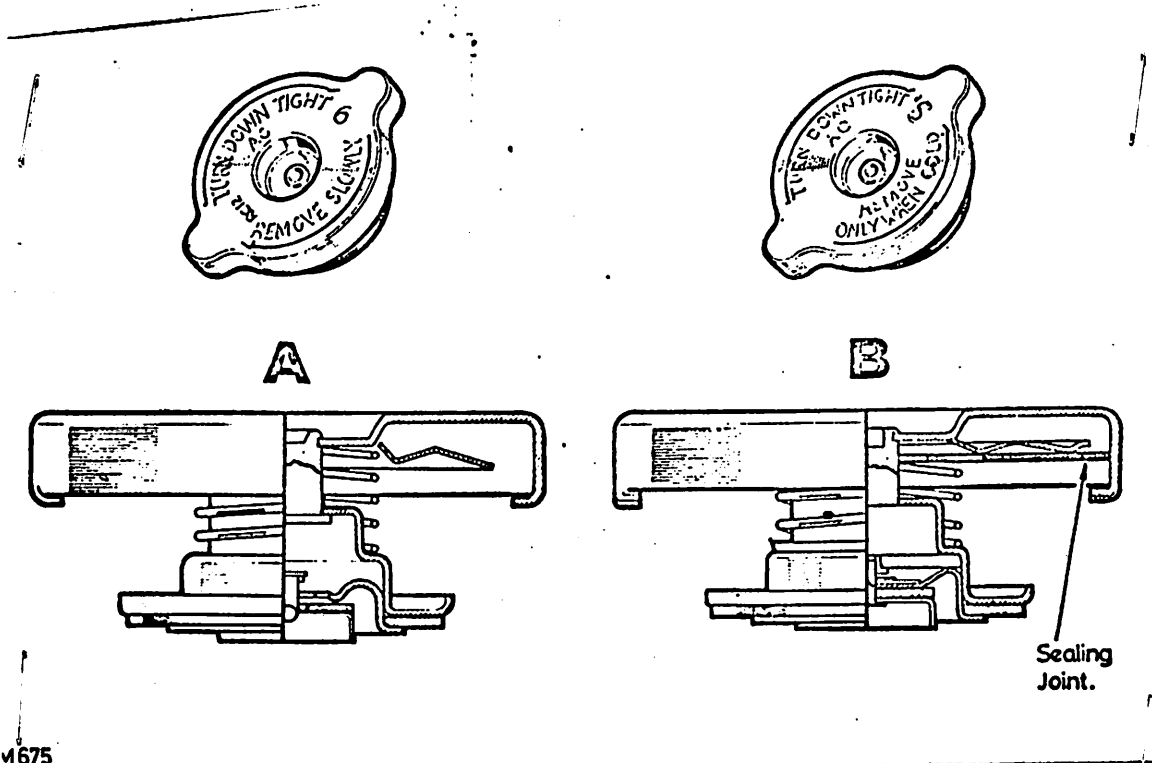
Radiator filler cap identification

It has been brought to our notice that lost or stolen radiator caps are sometimes being replaced by the earlier type cap, Part No. 509767, which does not comprise a sealing joint. The use of this cap renders the overflow system ineffective by admitting air into the system during the cooling off period, and thus preventing the coolant trapped in the overflow bottle returning to the header tank. Deprived of the correct quantity of coolant in the system, the engine may overheat and could suffer serious damage.

In order to eliminate this danger, radiator filler cap, Part No. 564713 will be supplied for all Service replacements, when stocks of Part No. 509767 are exhausted.

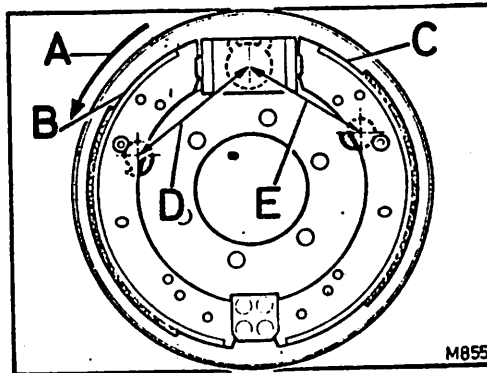
Fig. 1 Correct fitting of rear brake shoes

REMARKS: We have received reports of rear brake shoes being refitted the wrong way round, with the result that correct adjustment of the rear brakes is not possible. As shown at Fig. 1, there is a dimensional difference between the location of the shoe lining on the leading and the trailing shoes. There is also a corresponding dimensional difference in the location of the snail cams when measured from cam centre and the centre of the wheel cylinder aperture.
Distributors and Dealers are asked to bring this very important point to the notice of their Workshop staff.
It is essential that rear brake shoes are fitted correctly, as illustrated, to ensure correct operation of the adjustment mechanism.

- A—Direction of rotation
 - B—Leading shoe
 - C—Trailing shoe
 - D—4.5 in. (114.30 mm)
 - E—4.25 in. (107.95 mm)
- Note that the leading shoe lining is a greater distance from the wheel cylinder than that of the trailing shoe

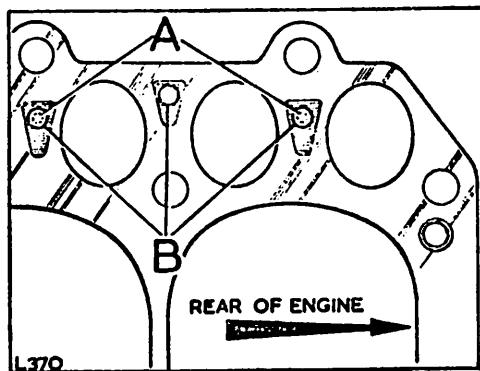
Fig. 1 Modification to cylinder head gasket

MODIFICATION: Introduction of modified cylinder head gasket to prevent engine overheating when the vehicle is operating under high ambient temperatures.

PART NUMBER: Cylinder head gasket 1 558160
