ROVER OWNERS' ASSOCIATION

OF NORTH AMERICA

Volume IV, Number 2

March, 1975

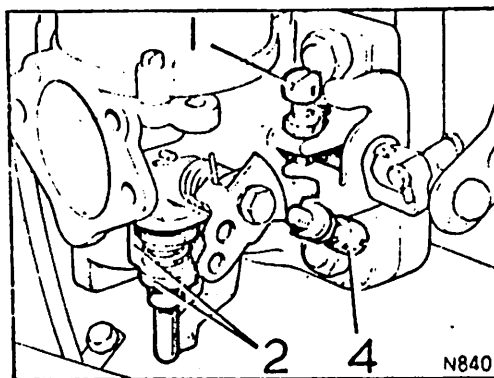
Fig. 4 Carburetter adjustment screws

Ref. 4 indicates fast idle screw SC and Automatic models

1. Warm up engine to normal running temperature.
2. Pull out the choke knob on to enrichment, and then push in to 14 mm–16 mm ($\frac{9}{16}$ in.– $\frac{5}{8}$ in.) from the console, and lock in position. Ensure the carburetter jets have returned fully home.

3. Loosen fast idle lock nuts and unscrew fast idle screw(s), until just clear of cams with throttle closed.
4. Turn the fast idle screw in by hand to obtain an engine speed of 1,500–1,600 r.p.m. Blip the throttle at each alteration of the fast idle screw to seat the screw. For T.C. models, turn each screw in by EQUAL amounts to obtain a fast idle speed of 1500/1600 r.p.m.

5. Re-lock the fast idle lock nut securely.
6. Push the choke knob in, pull it out again to enrichment then push it in to 14 mm–16 mm ($\frac{9}{16}$ in.– $\frac{5}{8}$ in.) from the console. Re-check the fast idle speed. PLEASE NOTE THAT THE CHOKE WARNING LIGHT HAS NO CONNECTION WITH FAST IDLE.

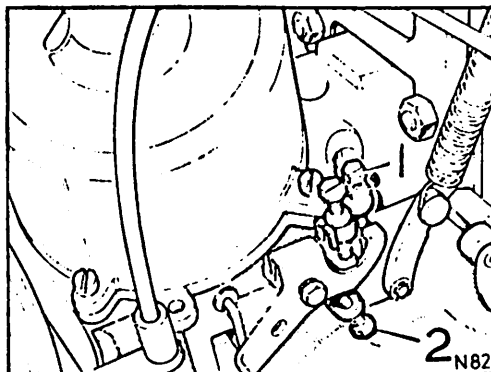
Fig. 5 Carburetter adjustment screws

Ref. 2 indicates fast idle screw TC models

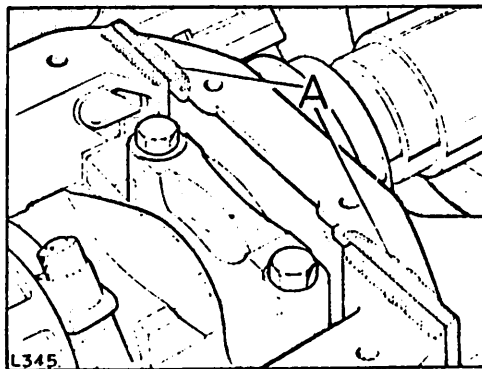
Fig. 1 Sealing cylinder block and front cover sump faces

REMARKS: Owing to minor discrepancies in alignment between the sump face of the cylinder block and the sump face of the front cover, it is essential that the following procedure is carried out:

A—Apply Hylomar SQ 32M in this area

1. Clean the sump mating surfaces at the join between front cover and cylinder block, using trichlorethylene or petrol.
2. Apply a coating of Hylomar SQ 32M approximately ½ in. to ¾ in. (12 mm to 18 mm) wide in the area 'A' at Fig. 1.
3. Fit engine sump gasket.
4. Proceed with sump fitting in the normal manner.

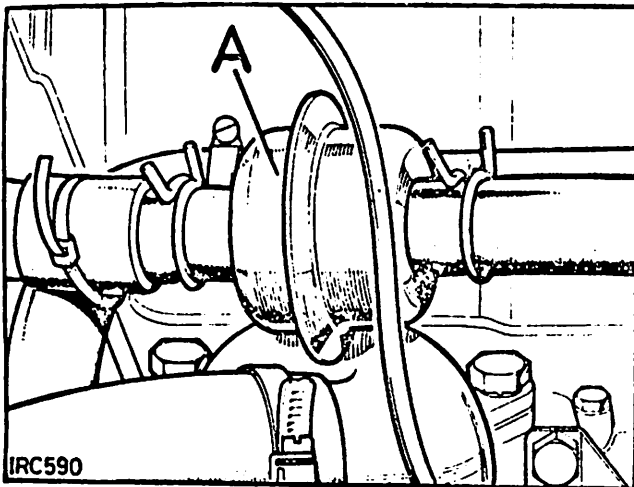
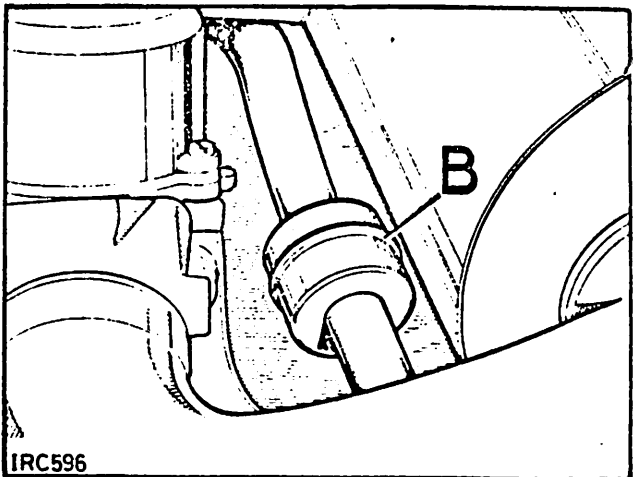
Fig. 2. Location of flame traps
A—2000 SC, illustrated B—3500 illustrated
Replace every 20.000 km (12,000 miles).

REMARKS: In view of the difficulty in cleaning flame traps satisfactorily, it is recommended that they are replaced at service intervals of 20.000 km (12,000 miles). Distributors and Dealers are requested to amend the literature in their possession accordingly. The various Owner's Manuals affected will be revised at the next available reprint.

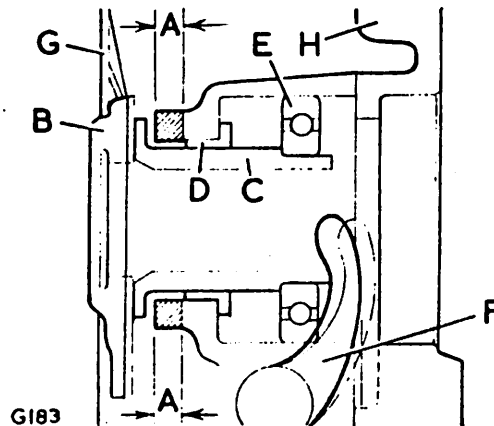
Fig. 3 Modification to clutch withdrawal housing

It has been brought to our attention that difficulty in operation and limited effective clutch plate life is sometimes experienced after clutch repairs have been carried out to earlier models. Investigations have shown that this has been caused by Distributors and Dealers failing to follow the instructions given in service News Letter Vol. 1, No. 46, item 323 and the Workshop Manual.

Failure to carry out this modification will allow the flange on the clutch withdrawal sleeve to foul the nose of the clutch withdrawal race housing as clutch plate wear takes place, thus limiting the effective life of the clutch plate.

To replace clutch assembly Part No. 539772 with Unipart GCC 126 it is essential to modify the clutch withdrawal housing in accordance with Fig 3.

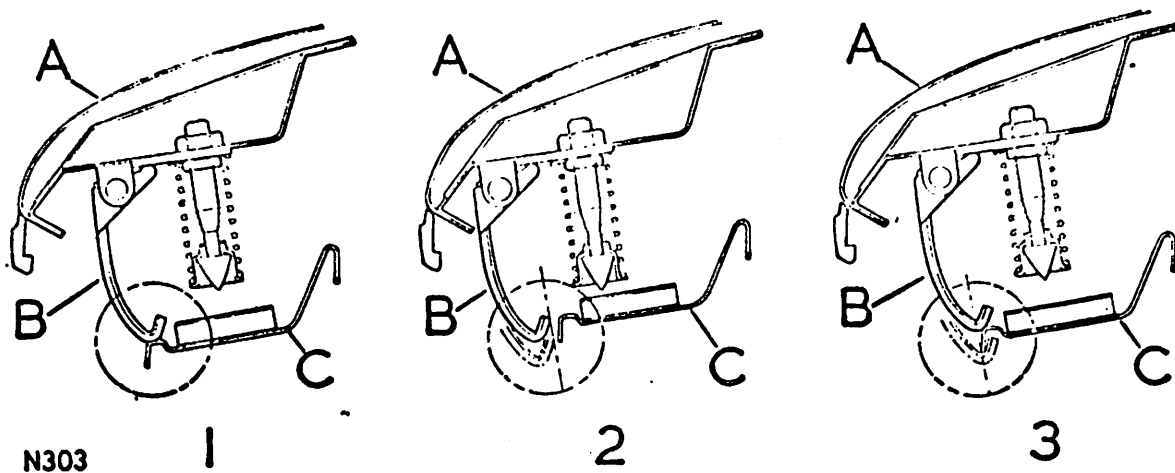
Fig. 1. Safety catch adjustment

With the correct adjustment, the safety catch should strike the panel for the bonnet lock platform at a point slightly forward of its peak, to ensure smooth engagement. See 'C' at Fig. 1.

If necessary, slacken the fixings and slide the safety catch backwards or forwards, until the correct setting has been obtained.

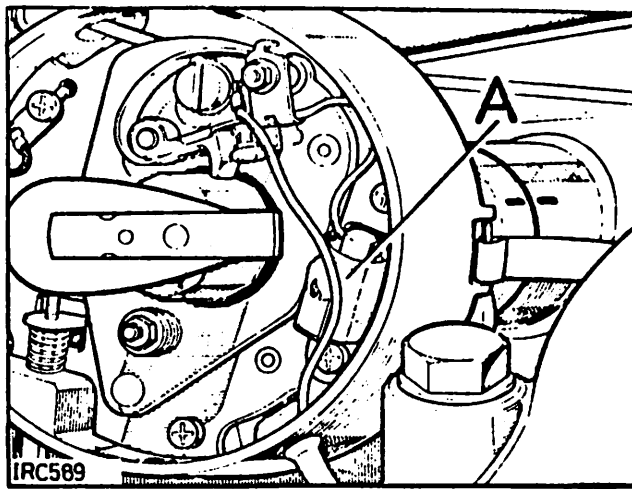
Fig. 1. Location of condenser

A—Condenser

Should full battery voltage be allowed to pass through the contact points, burning will result.

1. With the engine stopped, examine the condenser connections.
2. If connections are dirty and loose, arcing of the contact points will occur.
3. Rectification in this case, after checking regulator and ballast resistance, will be to renew the contact points, clean and tighten condenser connections and reset the distributor.

If the above items are found to be in good order, then the contact points themselves must be suspect. Rectification should be effected by replacing the contact set and condenser. Ensure that there is no copper weld splash on the new contacts.

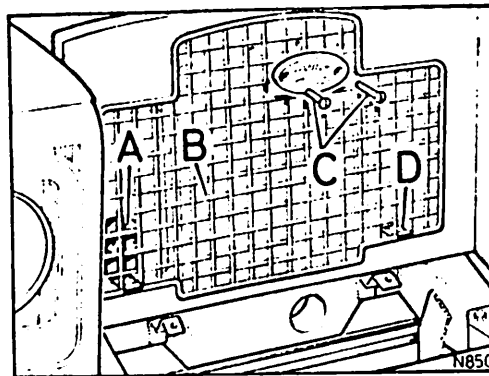
Fig. 2 Radiator grille

REMARKS: Some cases of steering relay seizure have been found to be caused by lack of lubrication.

The relay unit oil level should therefore be checked every 6.000 kms (4,000 miles). The oil should be clearly visible through the bolt hole in the relay top cover. Top up, as necessary. If significant topping up is required, check for oil leaks and fit new joint washers as necessary. The lubricating oil should not normally need replenishing between overhauls. Full details of the unit overhaul procedure are given in Land-Rover Workshop Manual, Part Two, Part No. 606408, Operation G1-10.

1. Remove name plate and withdraw the radiator grille.
