This is the first Rover Owners' Association Newsletter. As such it should be considered as the tentative format for the future publication of the Association. The main goal of this edition is to recruit membership and thereby bring formally into existence the North American branch of the Rover Owners' Association. As a result, perhaps the most important section of this Newsletter appears at the very end: An application form for joining the Association.

The Rover Owners' Association is primarily an association of clubs run by Rover and Land-Rover owners in England and Australia. To date, there has been no branch in the United States or on the continent of North America. The Headquarter Club of the Association is located at the Rover Company Limited in England. We were informed by Mr. B.J. Sperring, the Honorary Secretary of the Headquarter Club, that a North American branch of the Association could be formed with a minimum of ten interested parties who would accept and adopt the model rules of the Headquarter Club.

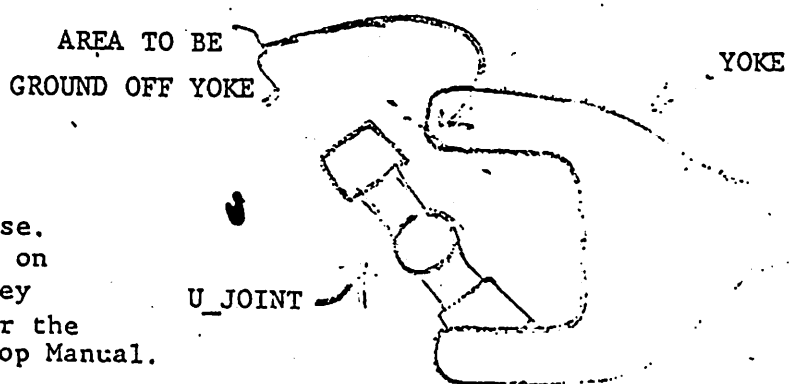
Two points need to be kept in mind when installing these units, however. First, take note of the position of the u-joint before you remove it from its yoke on the half-shaft. Replace it with your new one in exactly the same position. You will find that in order to allow sufficient room for the new u-joint's grease fitting you will have to keep the side of the u-joint with the grease fitting pointing away from the differential side and the wheel bearing/hub side of the half-shaft, respectively. Secondly, a small amount of metal will have to be filed or ground off of the edge of the yoke onto which you are going to install the U.S.-made u-joints. A diagram showing the area to be ground follows:

This area is only ground off of the yoke in order to allow the u-joint to be fitted since the shoulder of the u-joint is somewhat heavier than its British-made counterpart. In all other respects the fit is the same as the British unit. Of course, in order to perform this operation on the half-shaft and hub assembly they must be removed from the car as per the instructions in the Factory Workshop Manual.
