ROVER OWNERS' ASSOCIATION

Volume II, Number 2

April, 1973

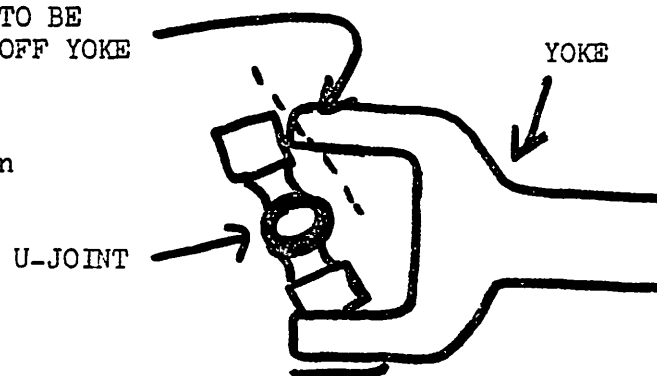
AREA TO BE
GROUND OFF YOKE

This area is only ground off of the yoke in order to allow the u-joint to be fitted since the shoulder of the u-joint is somewhat heavier than its British-made counterpart. In all other respects the fit is the same as the British unit. Of course, in order to perform this operation on the half-shaft and hub assembly they must be removed from the car as per the instructions in the Factory Workshop Manual.

In any case, as to the repair and/or maintenance of these u-joints: If you are blessed with the latter type of u-joint all that is required for normal maintenance (if the unit has not already dried out) is to screw out the plug which presently fills the space where the grease fitting should be, take the plug down to your local hardware or auto store, show the shopkeeper the size of the fitting needed, and pick up several grease fittings with which to replace the other plugs on the u-joints.
